Your Inspection Report

222 Somewhere Rd
Saint John, NB E2J 1J5

INSPECTION DATE:
Monday, December 4, 2023

RE: Report No. 3517
222 Somewhere Rd
Saint John, NB
E2J 1J5

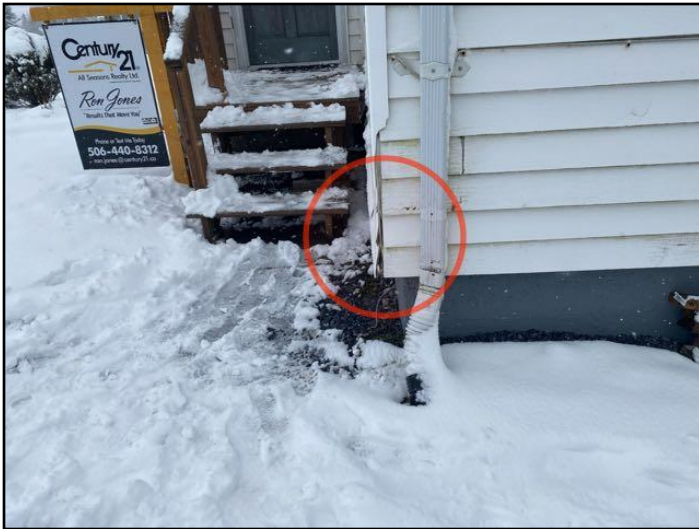
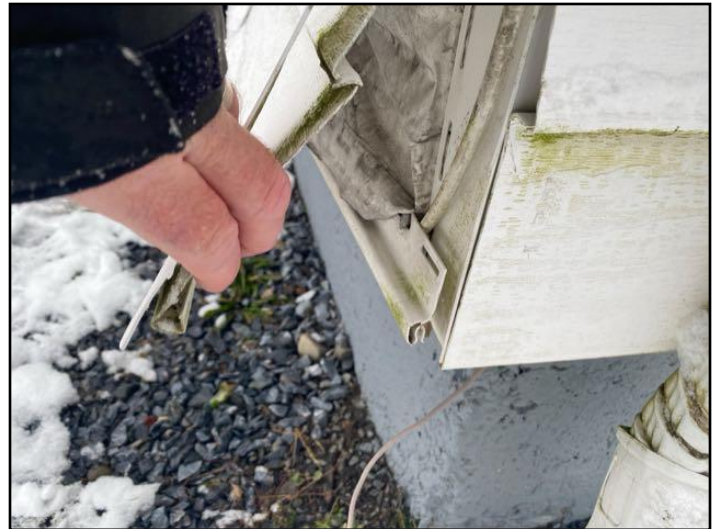
Condition: • There was a section of the siding that was pulling away from the main structure. This can allow for conditions conducive of moisture intrusion that can damage the underlying structural materials and interior finished surfaces. Recommend repair by a specialist.

Task: Service General Repair

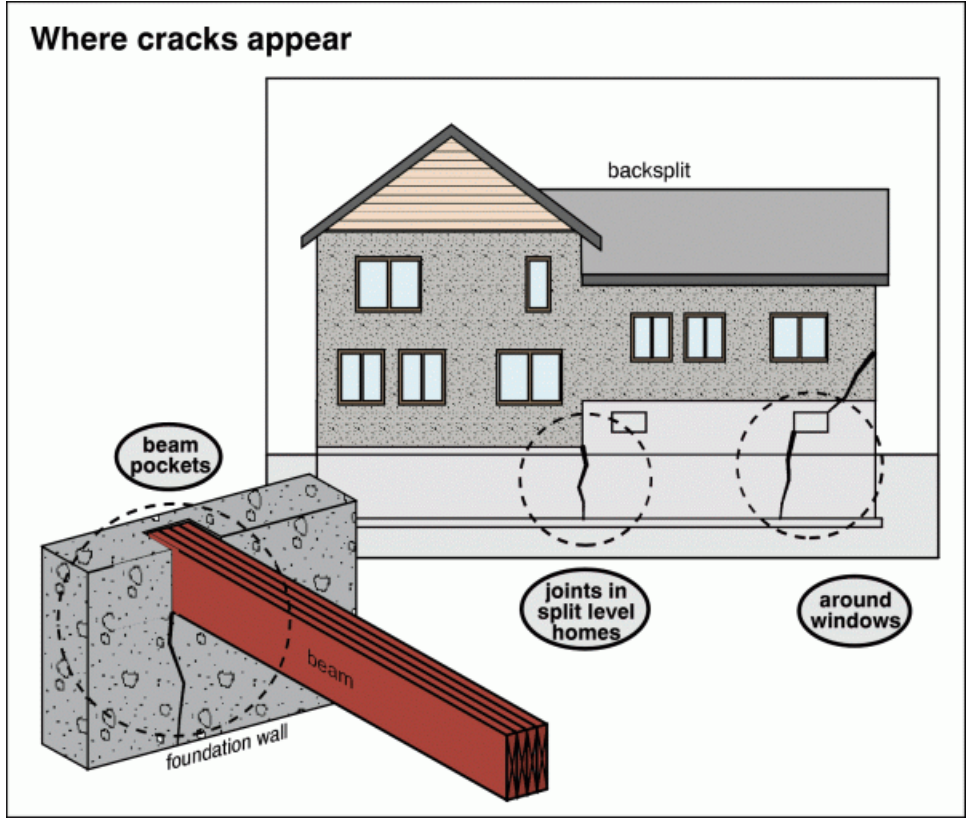
Condition: • [In our opinion, the cracks do not currently affect the serviceability of the structure, however, if present, even minor cracks can permit water entry into the home.](#) In that regard, the client should ensure that positive drainage exists around the perimeter of the home and that no downspouts discharge water near the foundation walls. In addition, the client may wish to seal or repair these cracks prior to occupancy to reduce the potential for water infiltration into the home. The inspector is at the home for a limited time and cannot predict future activity from weather or soil. Current technology permits cost-effective repairs of foundations from the interior as well as the exterior of the home. Inspector recommends a further evaluation from a specialist to provide a more detailed evaluation and cost and type of the repair needed

Implication(s): Vulnerability to water/moisture entry in the home

Location: Left and Rear Side Exterior Foundation

Task: Repair

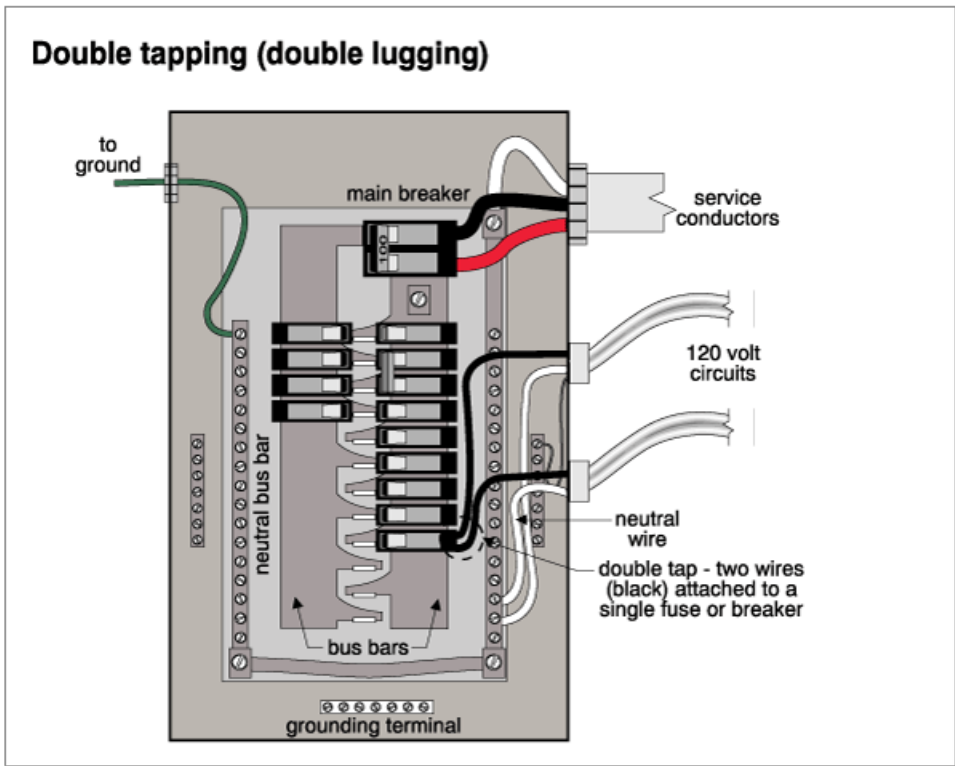
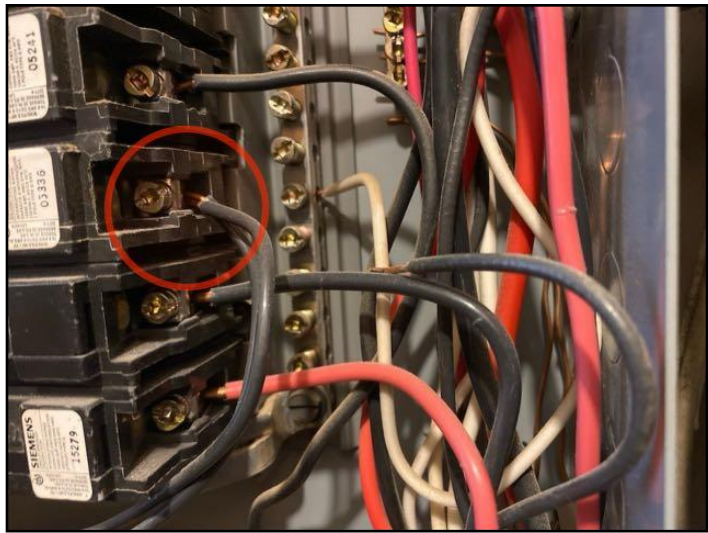
Condition: • There are breakers within the main electrical panel are doubled up (referred to as a "double tap"). A double tap is when two circuit wires are connected to only one breaker. The circuits should be separated so that each circuit is serviced by its own circuit breaker. A specialist should be consulted to make the necessary corrections.

Implication(s): Fire hazard

Task: Correct

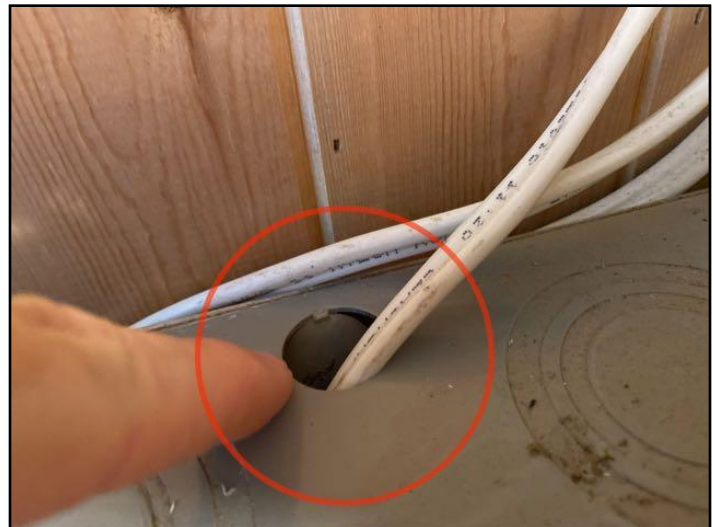
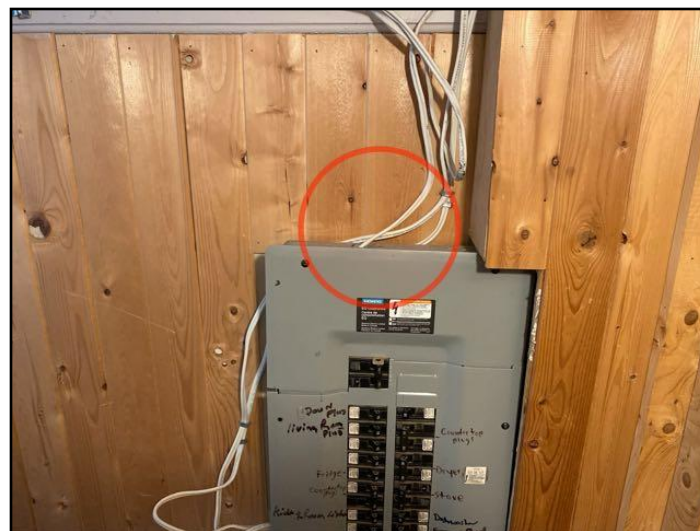
Condition: • [Not well secured](#)

Implication(s): Fire hazard | Electric shock

Task: Correct

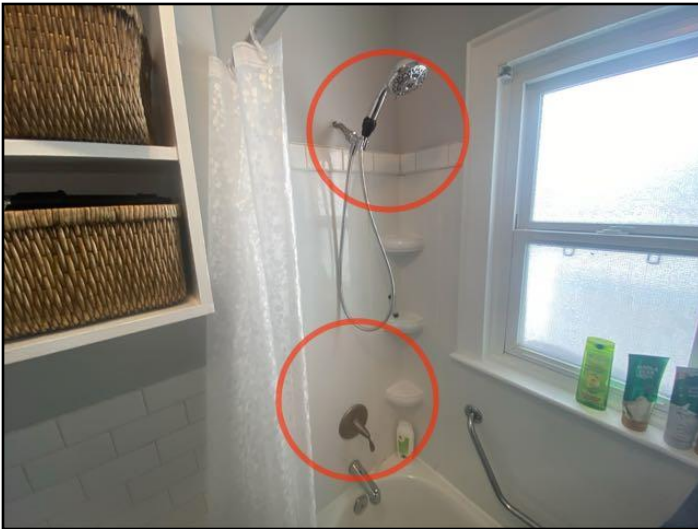
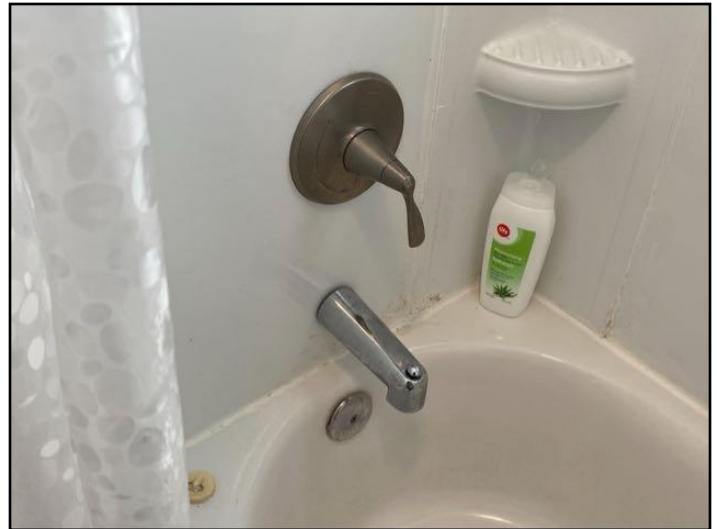
Condition: • [Poor support](#)

Tub and shower plumbing and faucet were loose

Implication(s): Leakage | Chance of water damage to structure, finishes and contents

Task: Repair

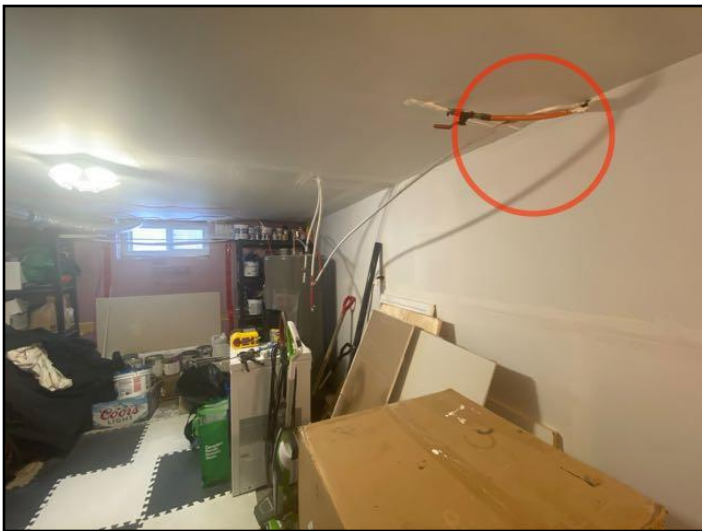
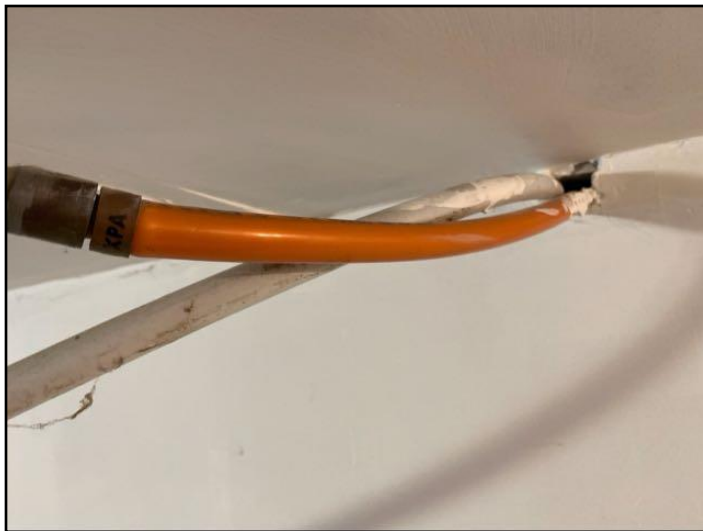
Condition: • Kitec has been the subject of a national class action lawsuit involving certain polybutylene plumbing systems and polybutylene yard service lines installed between 1995 through 2007. Some insurance companies have been known to request removal or disconnection of this plumbing prior to just after possession of the home.

Kitec plumbing noted at the basement

Implication(s): Chance of water damage to contents, finishes and/or structure | Reduced water pressure and volume

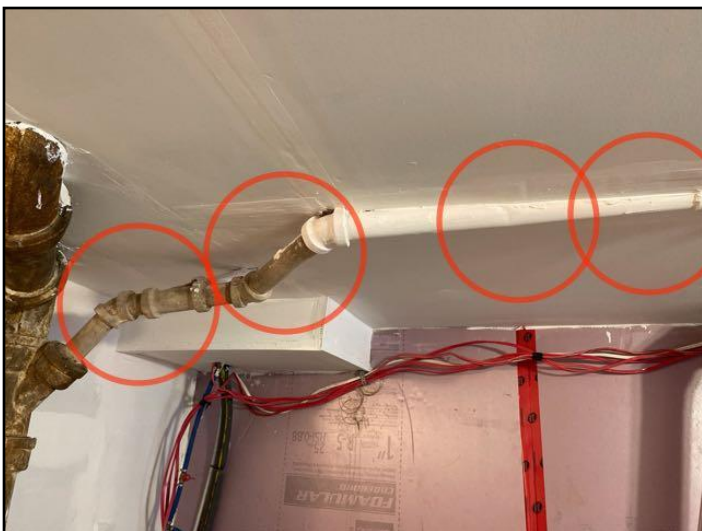
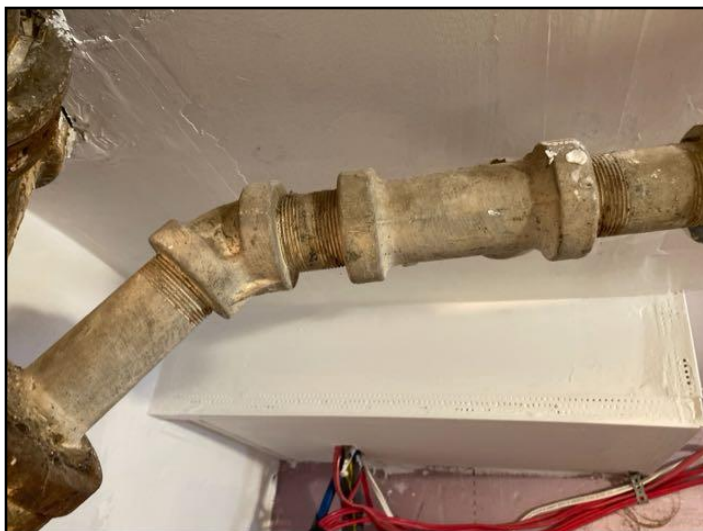
Condition: • Galvanized waste plumbing | Recommend replacing with current standard abs piping | Galvanized plumbing can rust and corrode from the inside

Implication(s): Leaking unpredictable | damage to interior and property

Task: Recommend Upgrade to Current Standard

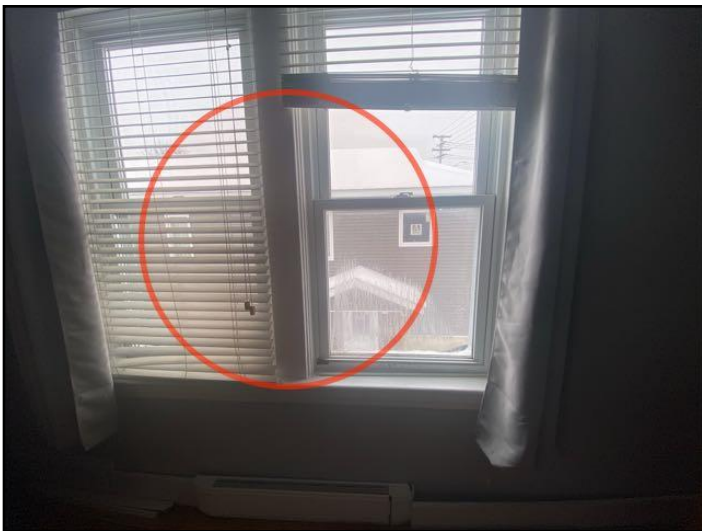
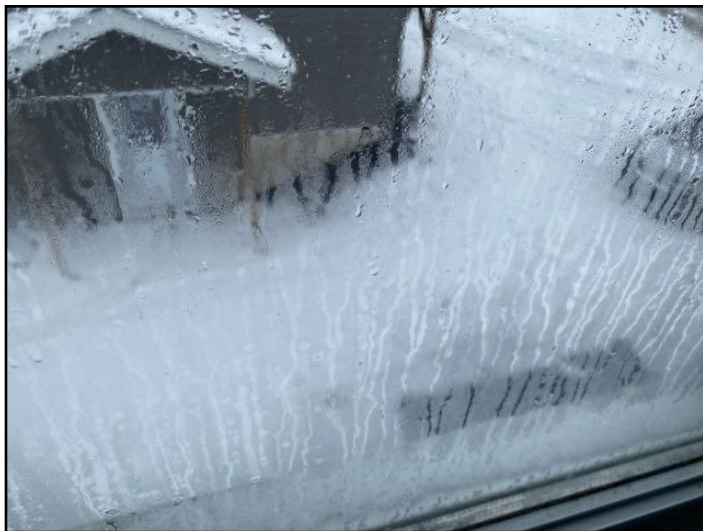
Condition: • Condensation between the glass thermal pane indicates that the seal has failed. Insulating performance may not suffer significantly but repair or replacement of the failed unit will likely be necessary to clear up the condensation and return the unit to its intended efficiency.

Task: Repair or Replace

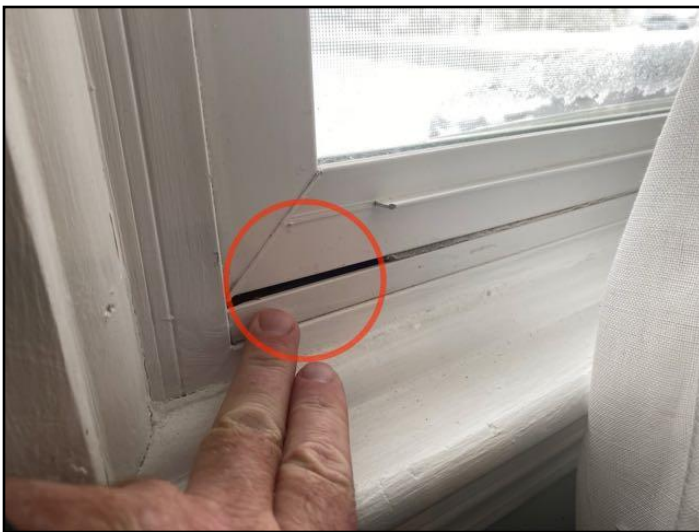
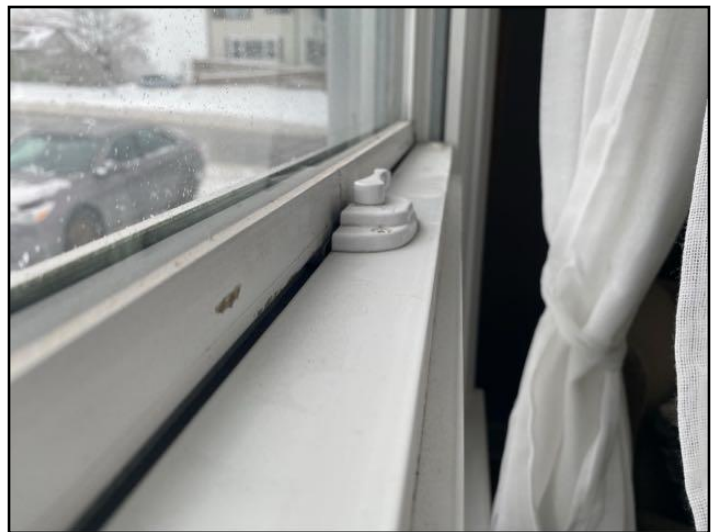
Condition: • Sashes did not fully seat into the sill | This will not allow the locks to operate and leaves minor air / heat loss

Task: Repair or Replace

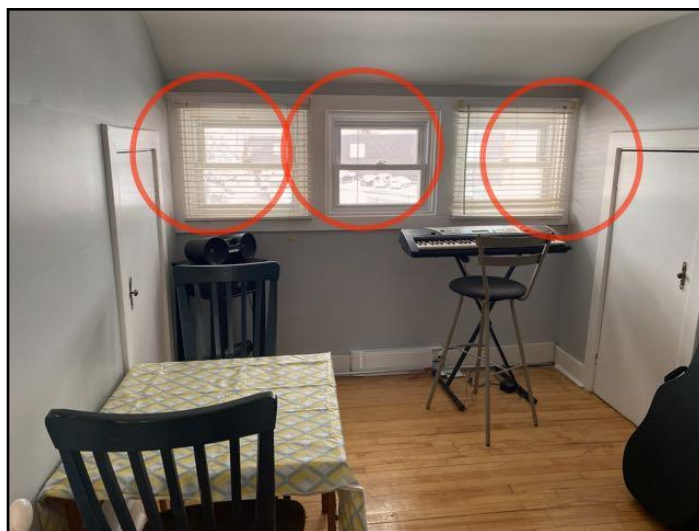
Condition: • [Too small](#)

Implication(s): Restricted emergency exits

Task: Recommend Upgrade to Current Standard

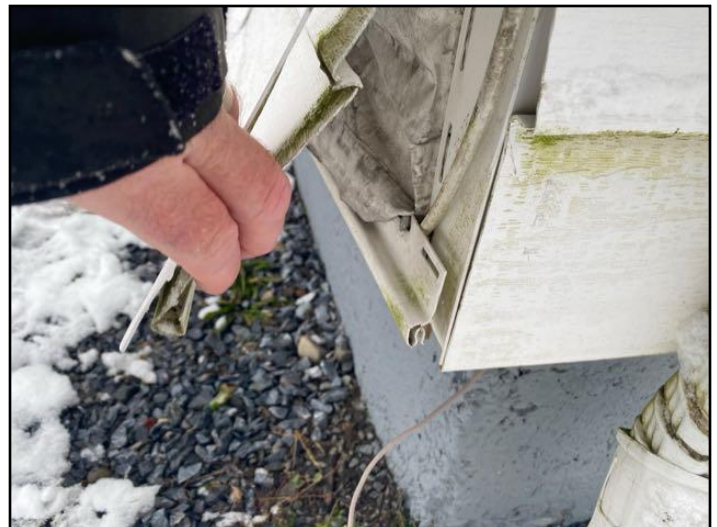
Condition: • There was a section of the siding that was pulling away from the main structure. This can allow for conditions conducive of moisture intrusion that can damage the underlying structural materials and interior finished surfaces.

Recommend repair by a specialist.

Task: Service General Repair

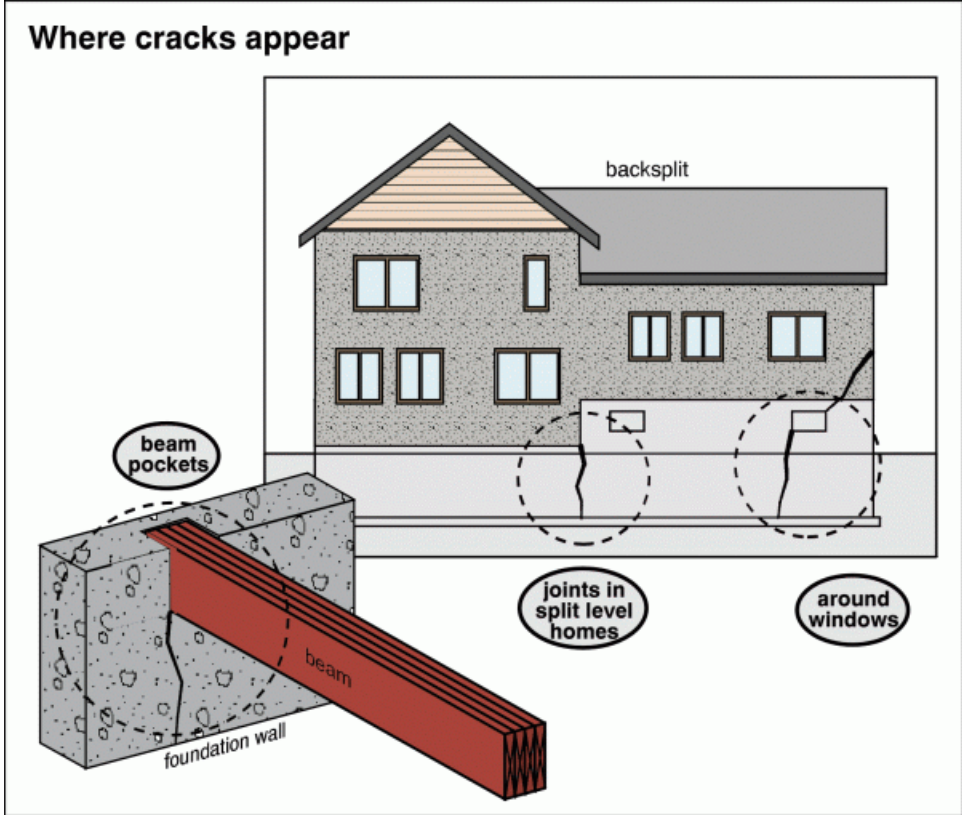
Implication(s): Vulnerability to water/moisture entry in the home

Location: Left and Rear Side Exterior Foundation

Task: Repair

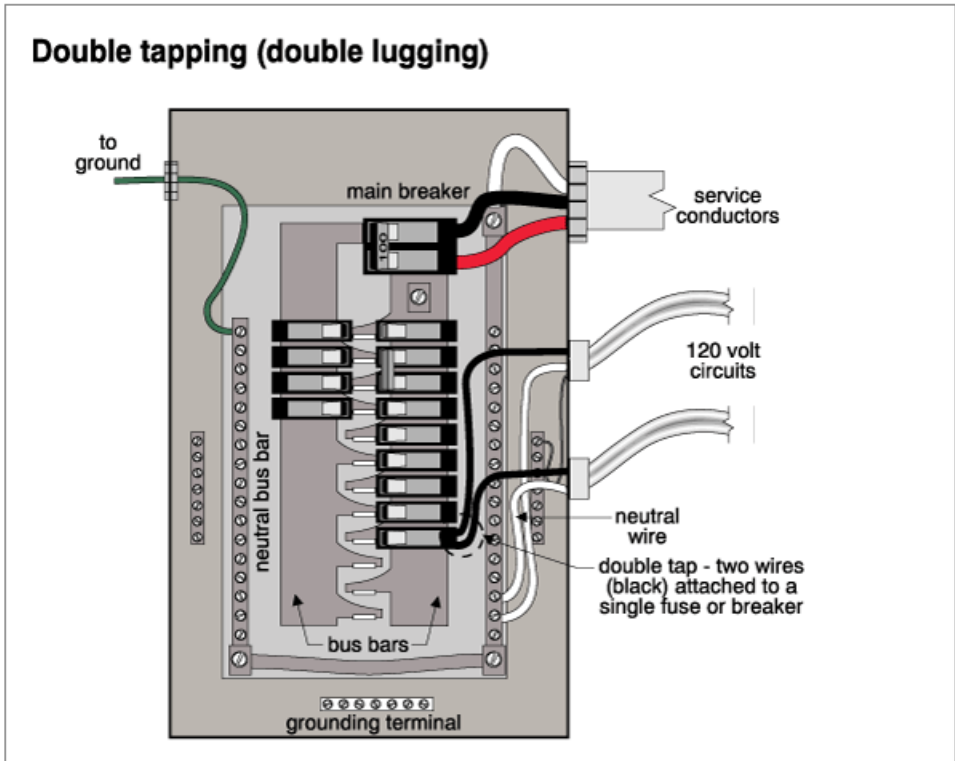
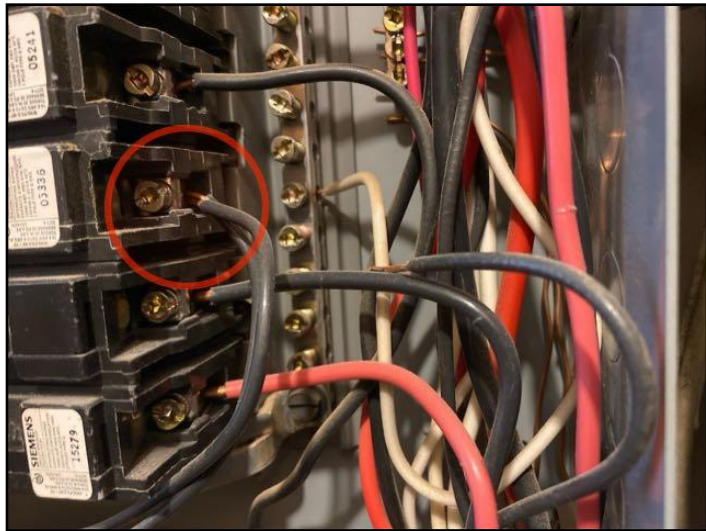
Condition: • [Not well secured](#)

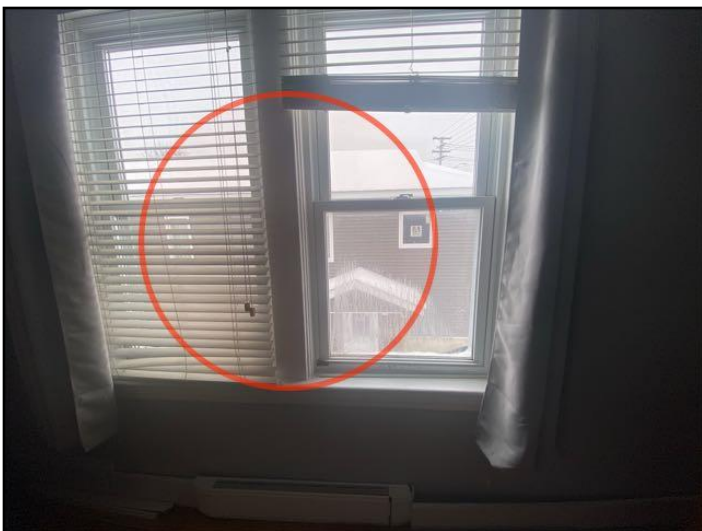
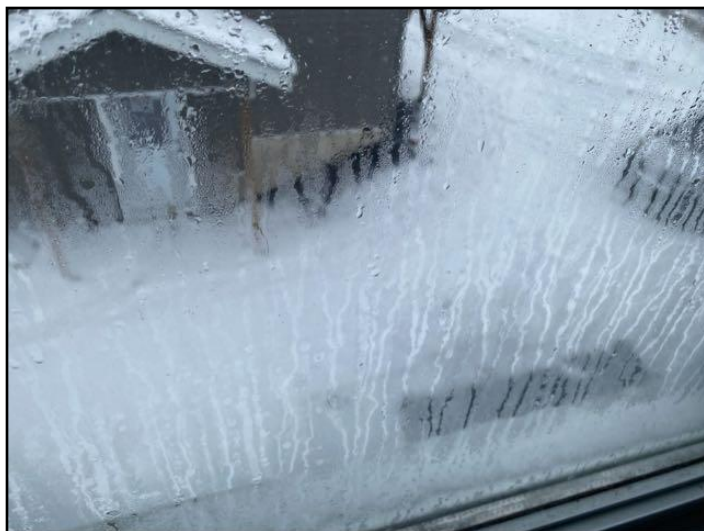
Condition: • Sashes did not fully seat into the sill | This will not allow the locks to operate and leaves minor air / heat loss
