Your Inspection Report

222 Somewhere Rd
Saint John, NB E2J 1J5

INSPECTION DATE:
Monday, December 4, 2023

RE: Report No. 3517
222 Somewhere Rd
Saint John, NB
E2J 1J5

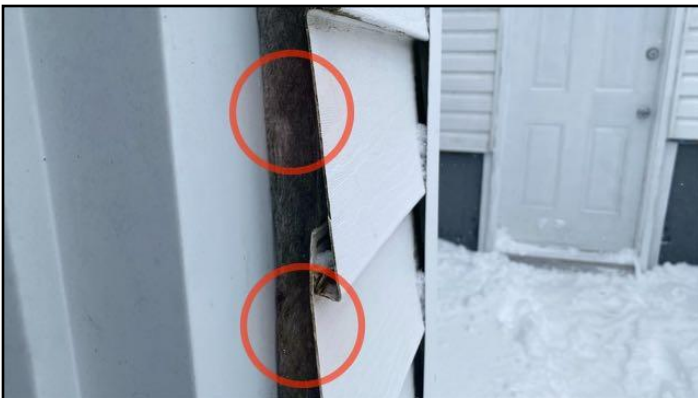
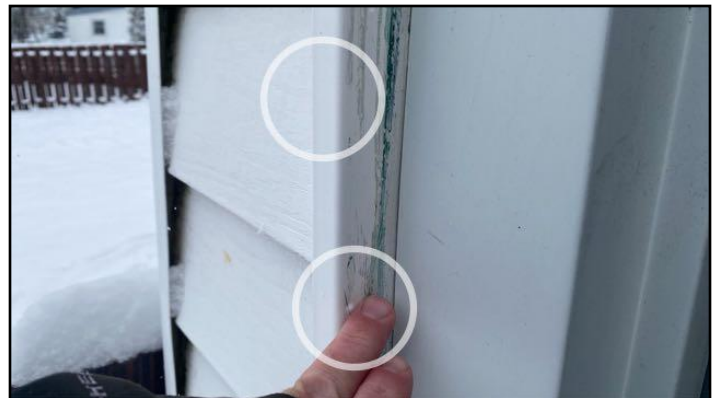
WALLS \ Vinyl siding

Condition: • There was a section of the siding that was pulling away from the main structure. This can allow for conditions conducive of moisture intrusion that can damage the underlying structural materials and interior finished surfaces. Recommend repair by a specialist.

Task: Service General Repair

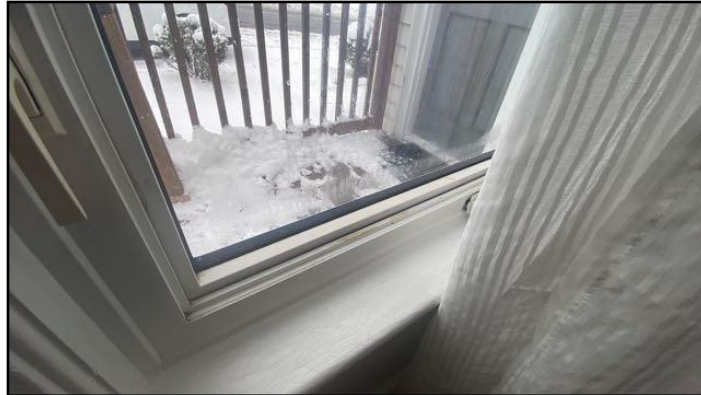
WINDOWS \ Sashes

Condition: • Sashes did not fully seat into the sill | This will not allow the locks to operate and leaves minor air / heat loss

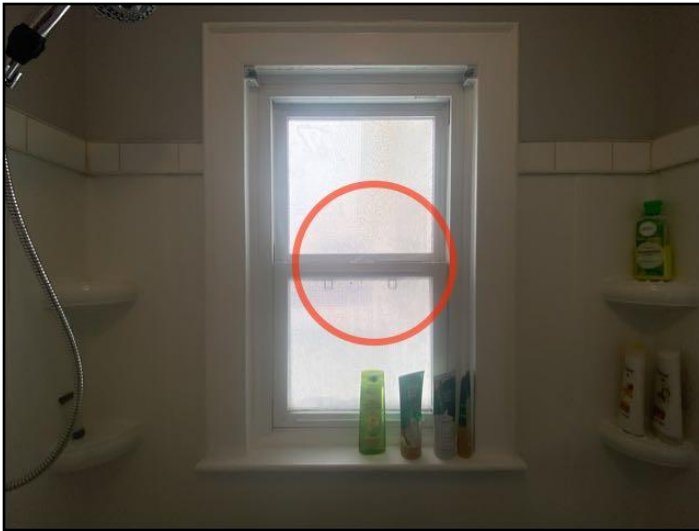
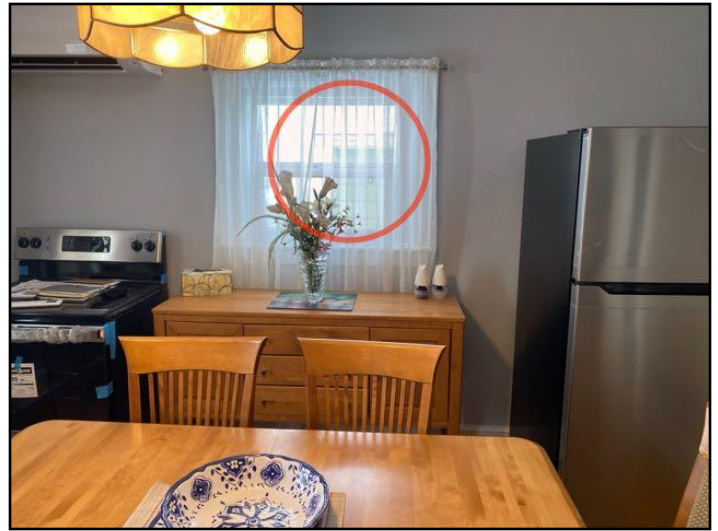
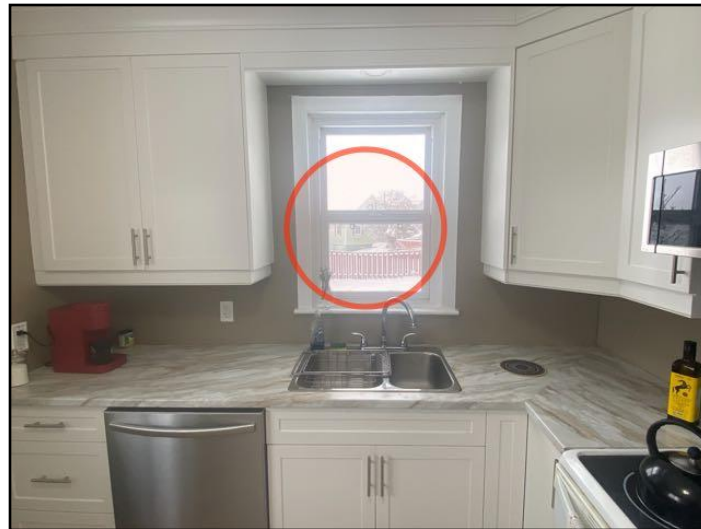
WINDOWS \ Hardware

Condition: • [Broken](#)

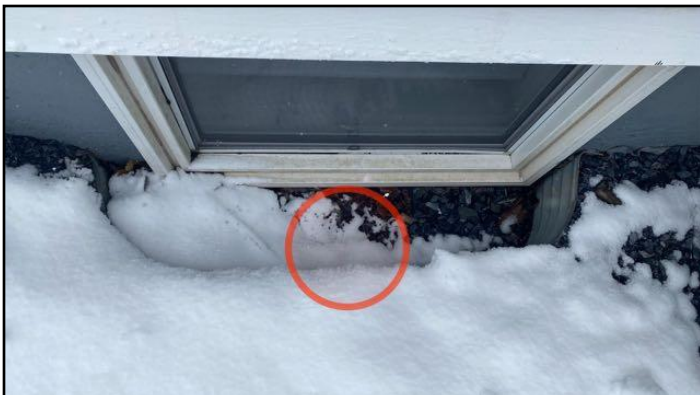
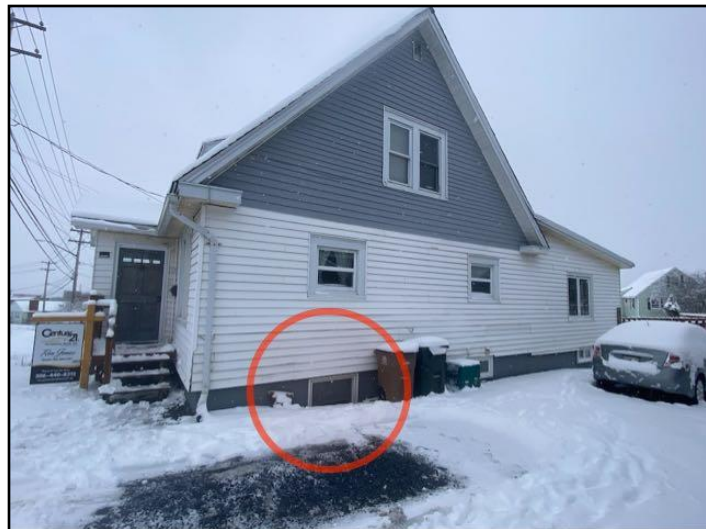
Condition: • [Too small](#)

Implication(s): Restricted emergency exits

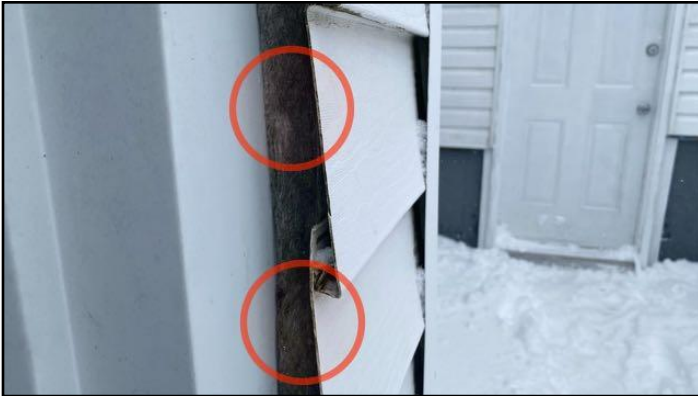
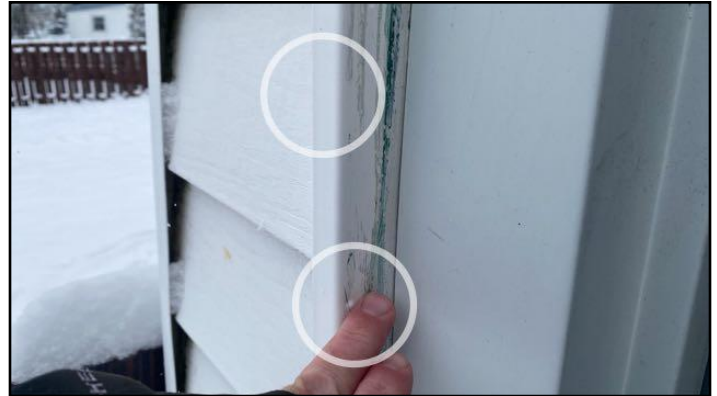
WALLS \ Vinyl siding

Condition: • There was a section of the siding that was pulling away from the main structure. This can allow for conditions conducive of moisture intrusion that can damage the underlying structural materials and interior finished surfaces.

Recommend repair by a specialist.

Task: Service General Repair

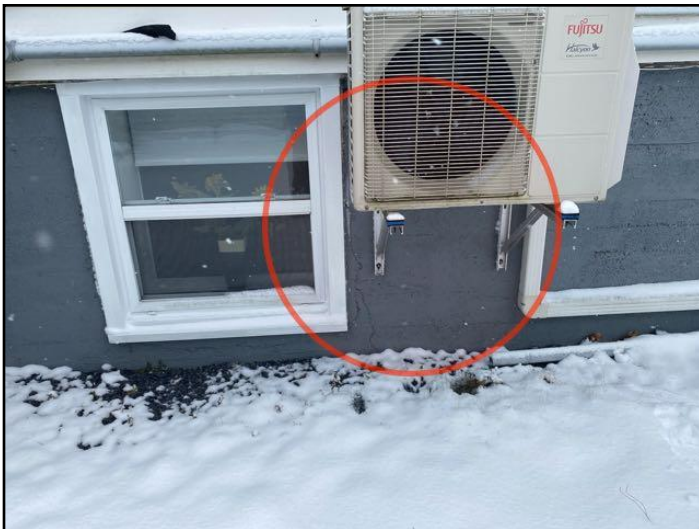
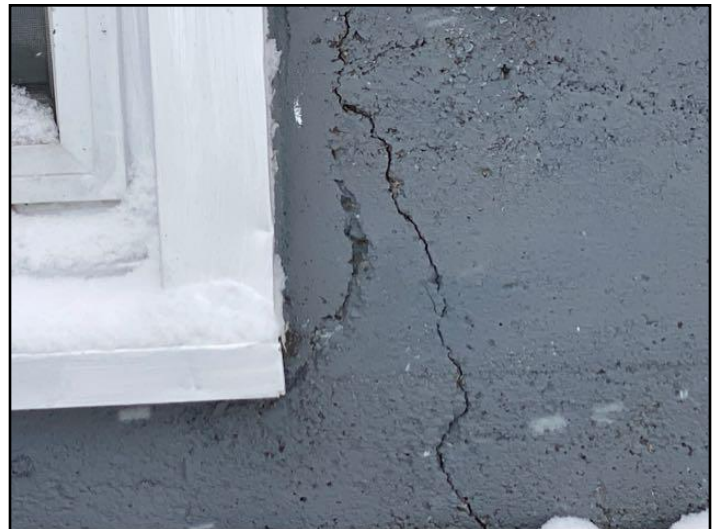
Location: Left and Rear Side Exterior Foundation

Condition: • [In our opinion, the cracks do not currently affect the serviceability of the structure, however, if present, even minor cracks can permit water entry into the home.](#) In that regard, the client should ensure that positive drainage exists around the perimeter of the home and that no downspouts discharge water near the foundation walls. In addition, the client may wish to seal or repair these cracks prior to occupancy to reduce the potential for water infiltration into the home. The inspector is at the home for a limited time and cannot predict future activity from weather or soil. Current technology permits cost-effective repairs of foundations from the interior as well as the exterior of the home. Inspector recommends a further evaluation from a specialist to provide a more detailed evaluation and cost and type of the repair needed

Implication(s): Vulnerability to water/moisture entry in the home

Task: Repair

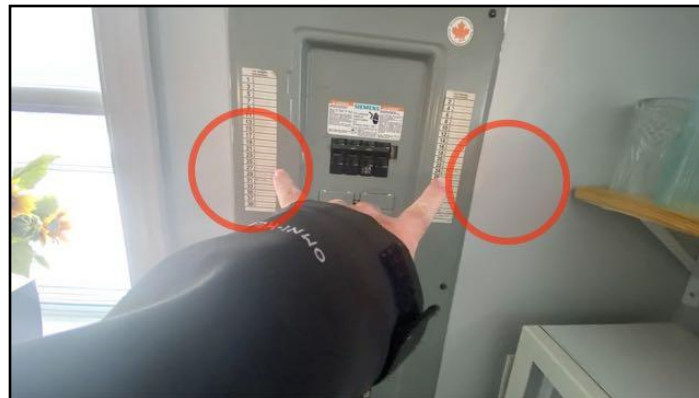
SERVICE BOX, GROUNDING AND PANEL \ Distribution fuses/breakers

Condition: • There are breakers within the main electrical panel are doubled up (referred to as a "double tap"). A double tap is when two circuit wires are connected to only one breaker. The circuits should be separated so that each circuit is serviced by its own circuit breaker. A specialist should be consulted to make the necessary corrections.

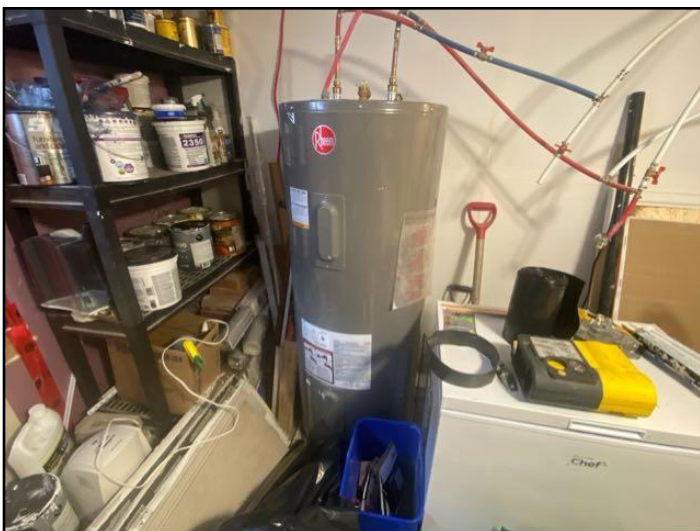
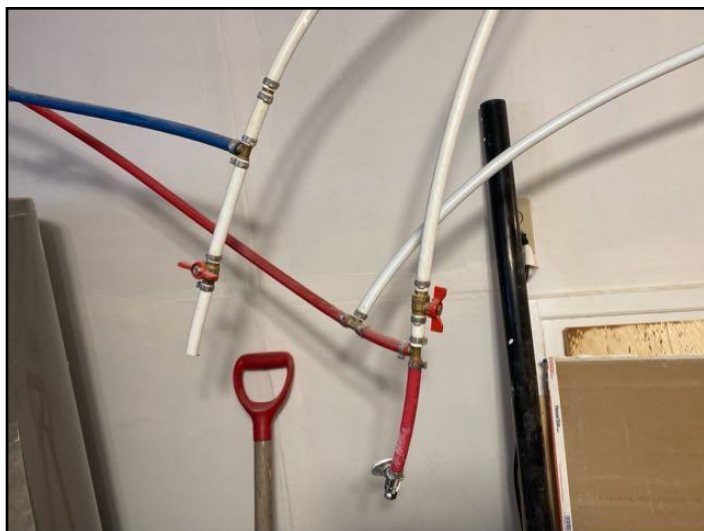
- General View

Water supply source (based on observed evidence): • Public

Service piping into building: • [Copper](#)

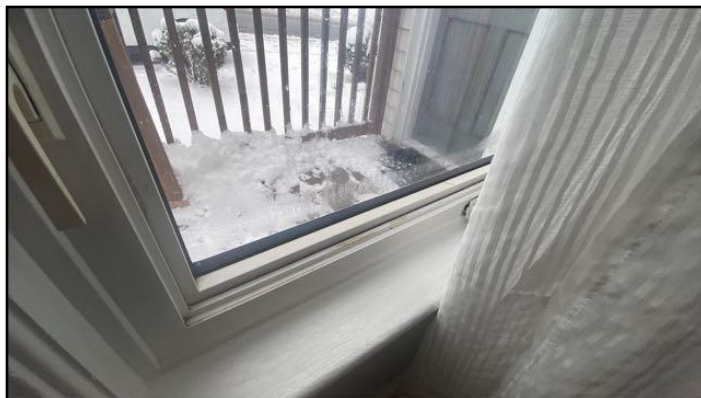
WINDOWS \ Sashes

Condition: • Sashes did not fully seat into the sill | This will not allow the locks to operate and leaves minor air / heat loss

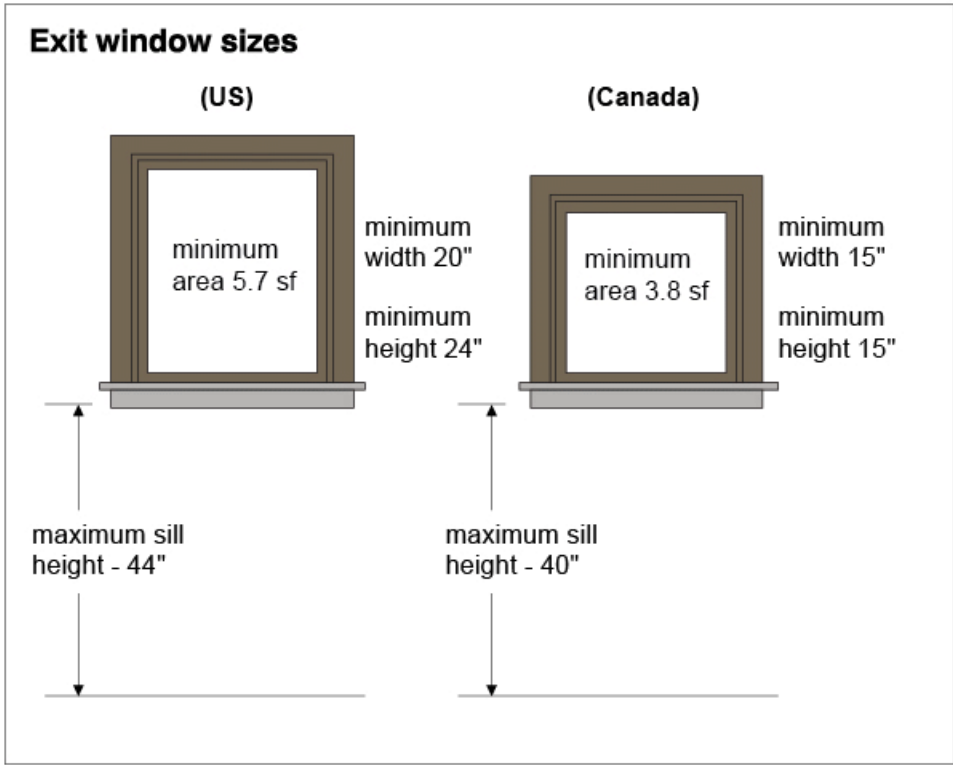
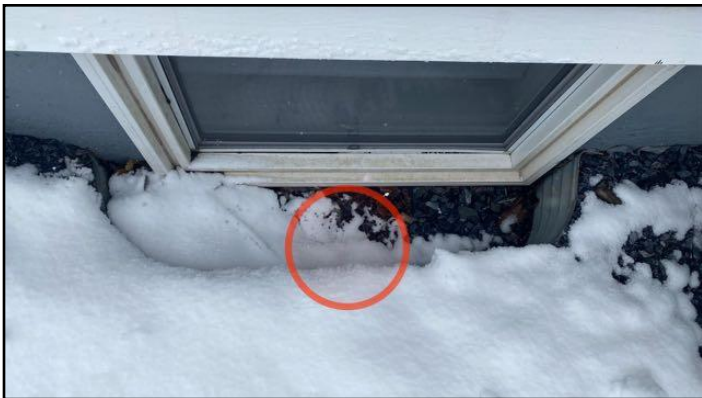
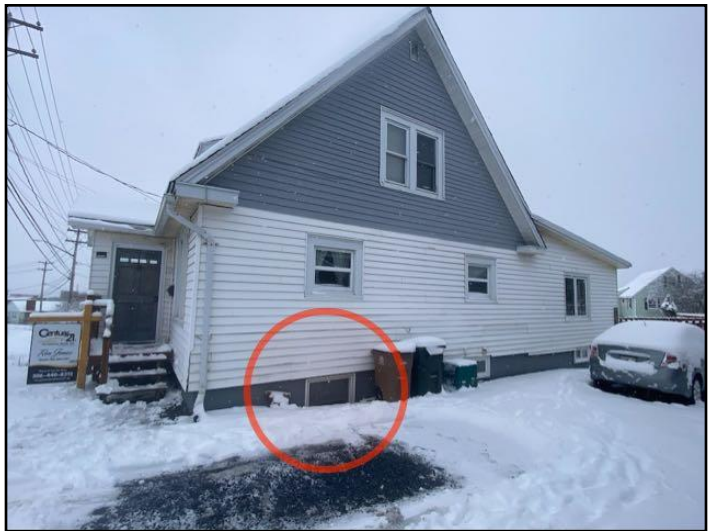
Condition: • [Too small](#)

Implication(s): Restricted emergency exits

Task: Recommend Upgrade to Current Standard
